# NATIONAL BUREAU OF STANDARDS REPORT

## FIRE ENDURANCE TESTS OF PREFABRICATED EXTERIOR WALL PANELS

by  
J. V. Ryan and R. W. Bender

Fire Endurance Tests of Prefabricated Exterior Wall Panels

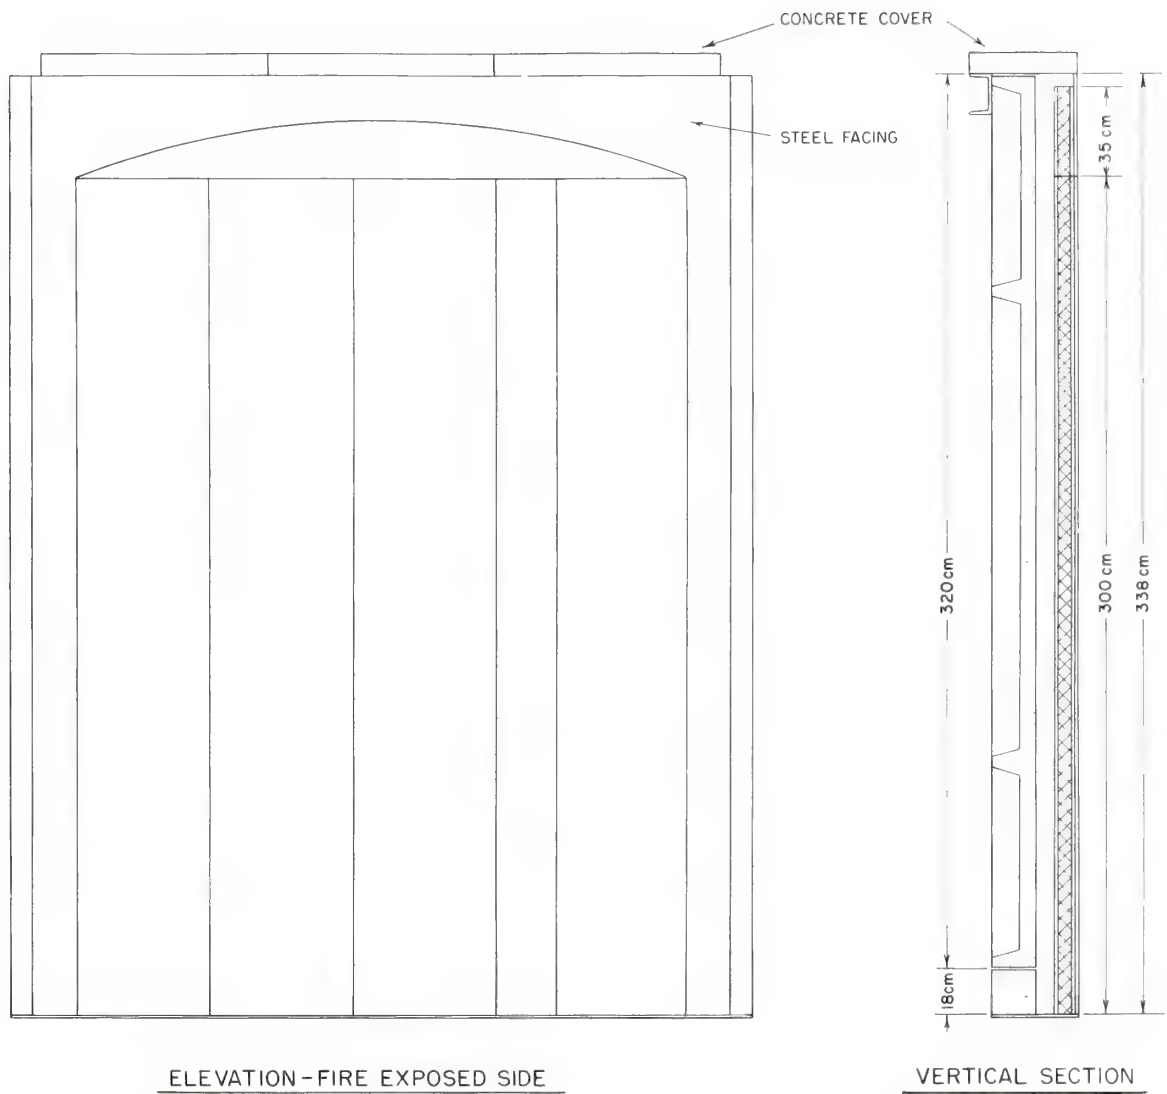
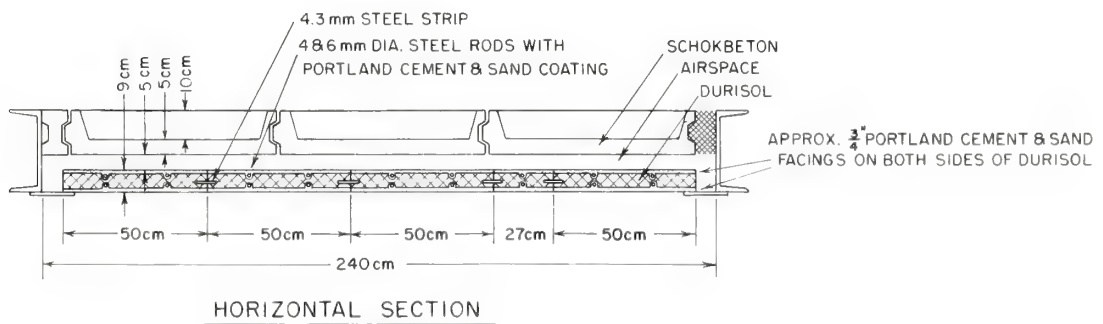
FIG. 1 CONSTRUCTION DETAILS OF TEST PANEL NO. 1

Test 1. A hollow wall with an air space of about 2 in. (5 cm) between the inner and outer faces. The outer face consisted of precast high density concrete channel slabs with transverse ribs. Each slab was 10 ft. 6 in. (320 cm) high, 2 ft. 5 1/2 in. (75 cm) wide, about 2 in. (5 cm) thick through the web and about 5.9 in. (15 cm) thick through the channel flanges and transverse ribs. The exterior sides of the flanges were formed to fit the flanges of the adjoining slabs in a tongue-and-groove system. The slabs were cast in form on a shock table and shocked repeatedly to obtain the high density. The inner face consisted of a pressed board of wood shavings bonded with portland cement which was coated on both sides with about 3/4 in. of a portland cement and sand mixture, giving an overall thickness of about 4 in. The total thickness of the test specimen was about 12 in. The details are shown in figure 1.

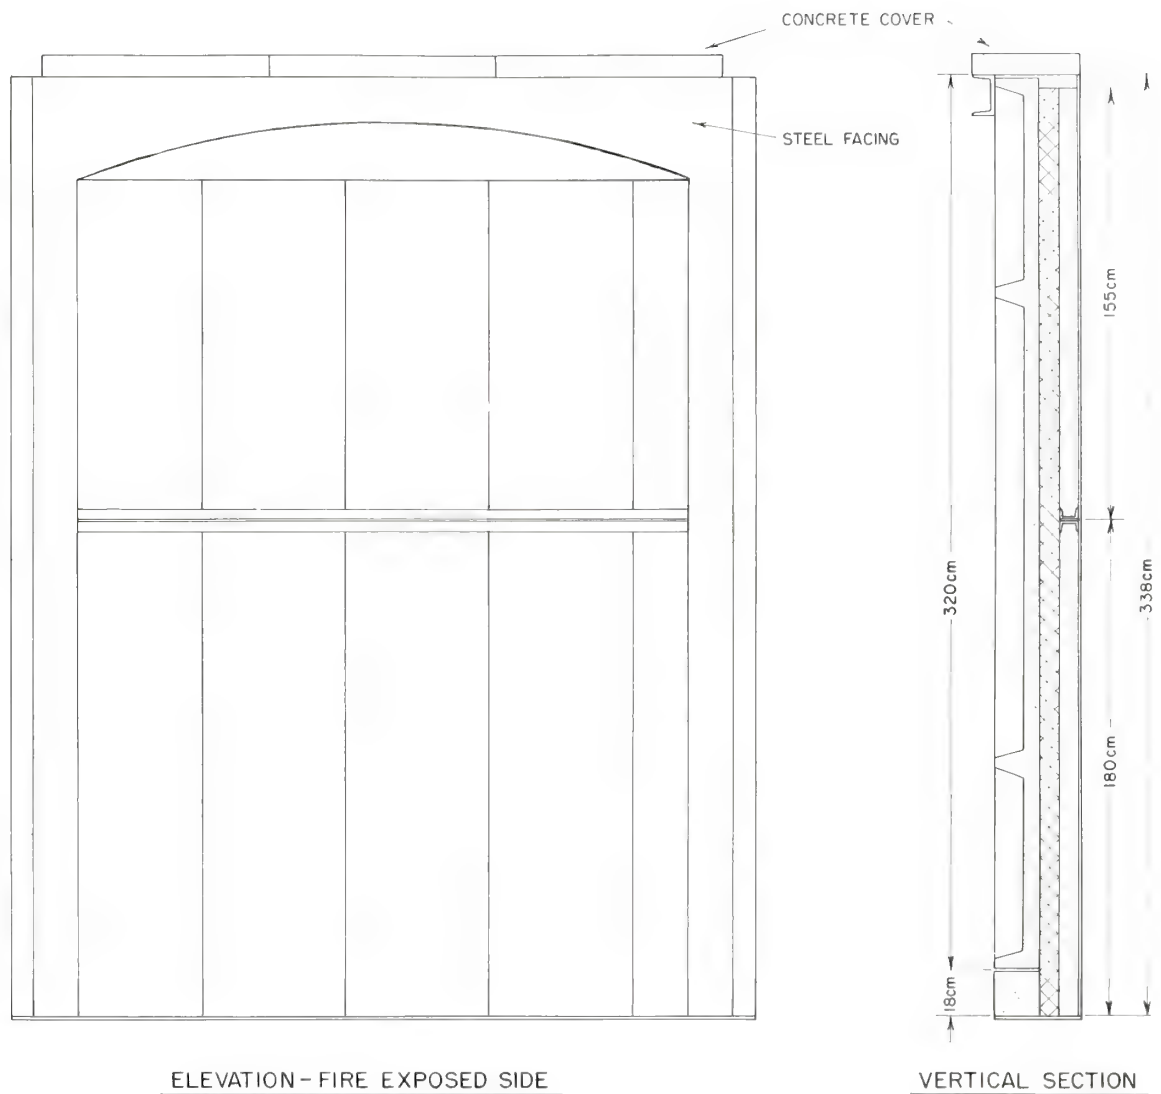
*FIG. 2 CONSTRUCTION DETAILS OF TEST PANEL NO.2*

Test 2. A sandwich wall with 2 in. of mineral wool insulation between the inner and outer faces. The outer face was of the same type materials and design as that in test 1. The inner face consisted of pumice concrete slabs 4 in. thick. The details are shown in figure 2.

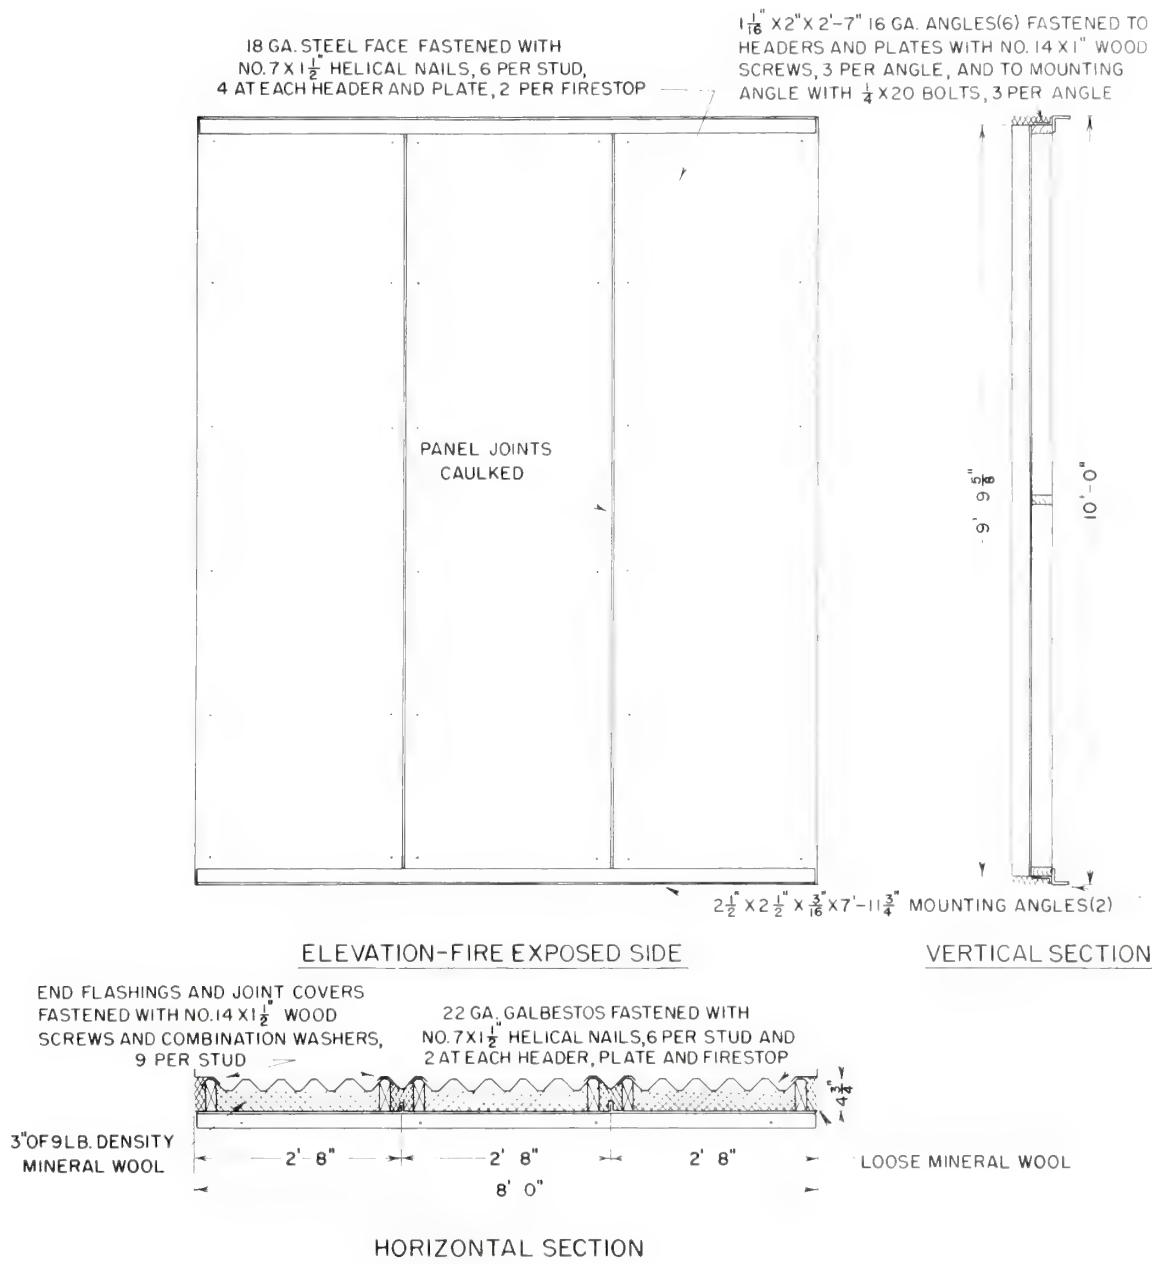
*FIG. 3 CONSTRUCTION DETAILS OF TEST PANEL NO.3*

Test 3. A wall consisting of three prefabricated panels, each of which was 9 ft. 11 3/4 in. high, 2 ft. 5 in. wide, and 4 3/4 in. thick, overall. Each panel consisted of a rectangular wooden frame to one face of which had been attached a sheet of 18 gage steel plate which projected on both sides of the frame and was bent to form interlocking joints with neighboring panels. The interior of the 3 in. deep wood frame had been filled with 9 lb/ft<sup>3</sup> density mineral wool after which a corrugated sheet of 22 gage steel, coated with zinc, asbestos felt and a heavy asphaltic solution and aluminum painted on the outer side, had been attached to the other face of the frame. The mineral wool did not fill the 1 3/4 in. deep corrugations. The joints between panels in the interior or flat steel face were caulked and those in the exterior or corrugated face were stuffed with mineral wool and covered with full height 6 in. wide strips of the corrugated facing during erection. The details are shown in figure 3.

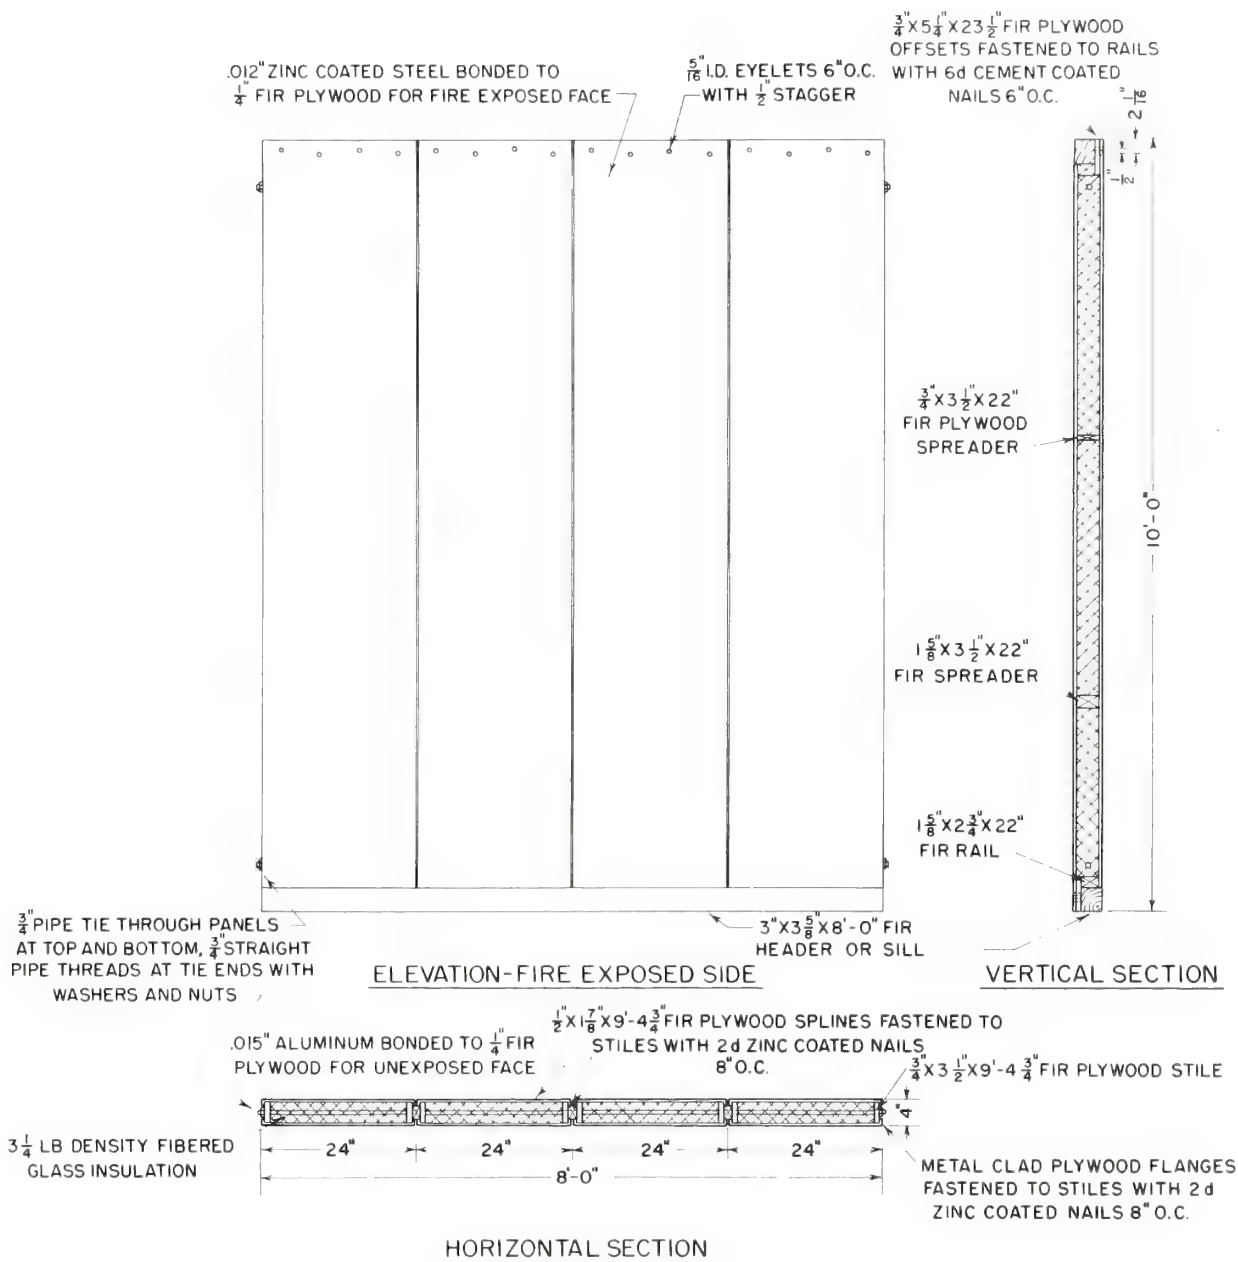
FIG. 4 CONSTRUCTION DETAILS OF TEST PANEL NO. 4

Test 4. A wall consisting of four prefabricated panels, each of which was 10 ft. high, 2 ft. wide, and 4 in. thick. Each panel consisted of a wood frame 9 ft. 4 3/4 in. high by 1 ft. 11 1/2 in. wide by 3/4 in. thick which had been faced on the interior side with 1/2 in. plywood clad with zinc coated steel and on the exterior side with 1/2 in. plywood clad with aluminum. The facings had been backed with asbestos paper and the space between facings filled with a glass fiber insulation. The interior face projected 3 5/8 in. above the wood frame and the exterior face 3 5/8 in. below, each backed with 3/4 in. additional plywood. These projecting lips had predrilled holes and eyelets for lag screws by which the panels were secured to 3 by 3 5/8 in. transverse sills at top and bottom during erection. All the surfaces of the wood components had been coated with a fire retardant paint except the metal clad faces of the plywood. The panels were tied together at erection by the sills and by 3/4 in. pipes which went through all four panels parallel to the faces near the top and bottom. The details are shown in figure 4.

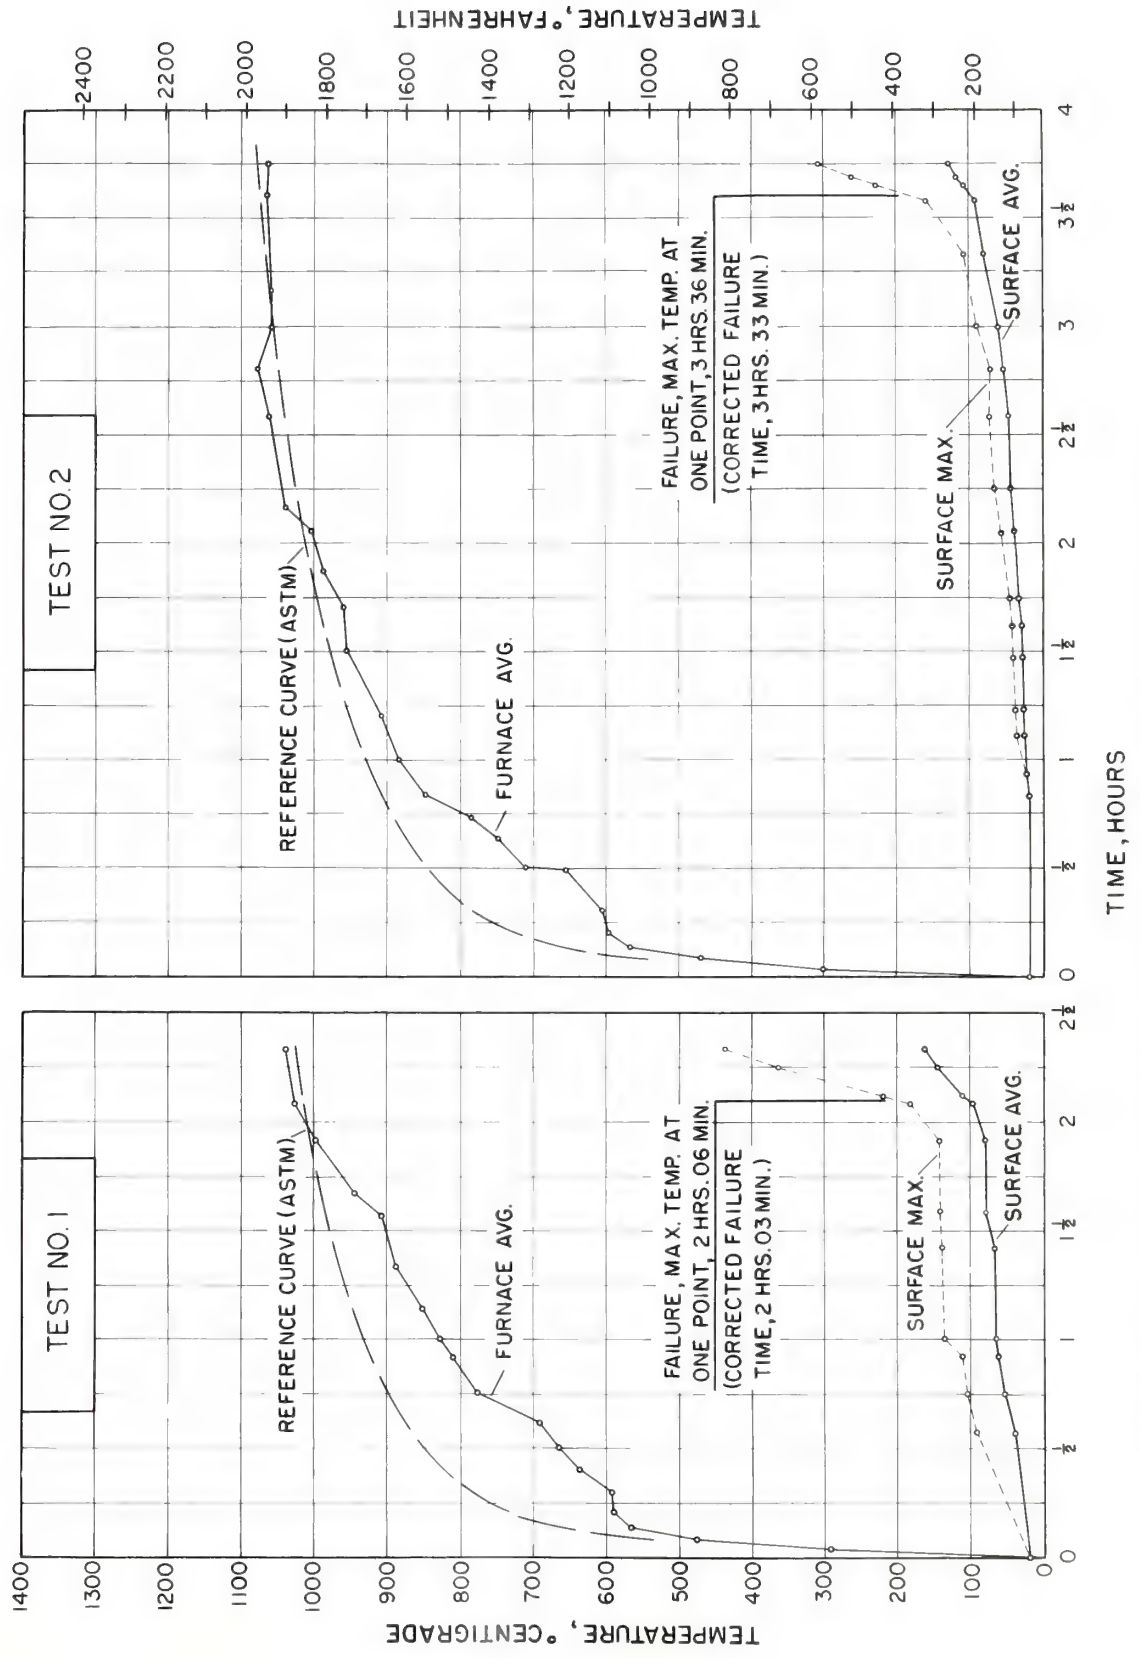
FIG. 6 TIME-TEMPERATURE CURVES FOR TESTS NO.1 AND 2

The control of the furnace temperature was such that the exposure severity was 59 percent of standard. The fire endurance limit was determined by temperature rise of 325 degrees F at one thermocouple on the unexposed surface at 2 hr. 6 min. The thermocouple was on the face of the center panel. If the correction formula in III-9 is applied to the temperatures indicated by the bare thermocouples, the correction is minus 3 min. Therefore, the corrected fire endurance is 2 hr. 3 min. The temperatures measured during the test are shown in Figure 6.

The control of the furnace was such that the fire exposure severity was 76 percent of standard. The fire endurance limit was determined at 3 hr. 36 min. by temperature rise of 325 degrees F at one thermocouple located on the unexposed face of the center panel in the upper half. If the correction formula in III-9 is applied to the temperatures as indicated by the bare furnace thermocouples, the correction is minus 3 min. Therefore the corrected fire endurance is 3 hr. 33 min. The temperatures measured during the test are shown in Figure 6.

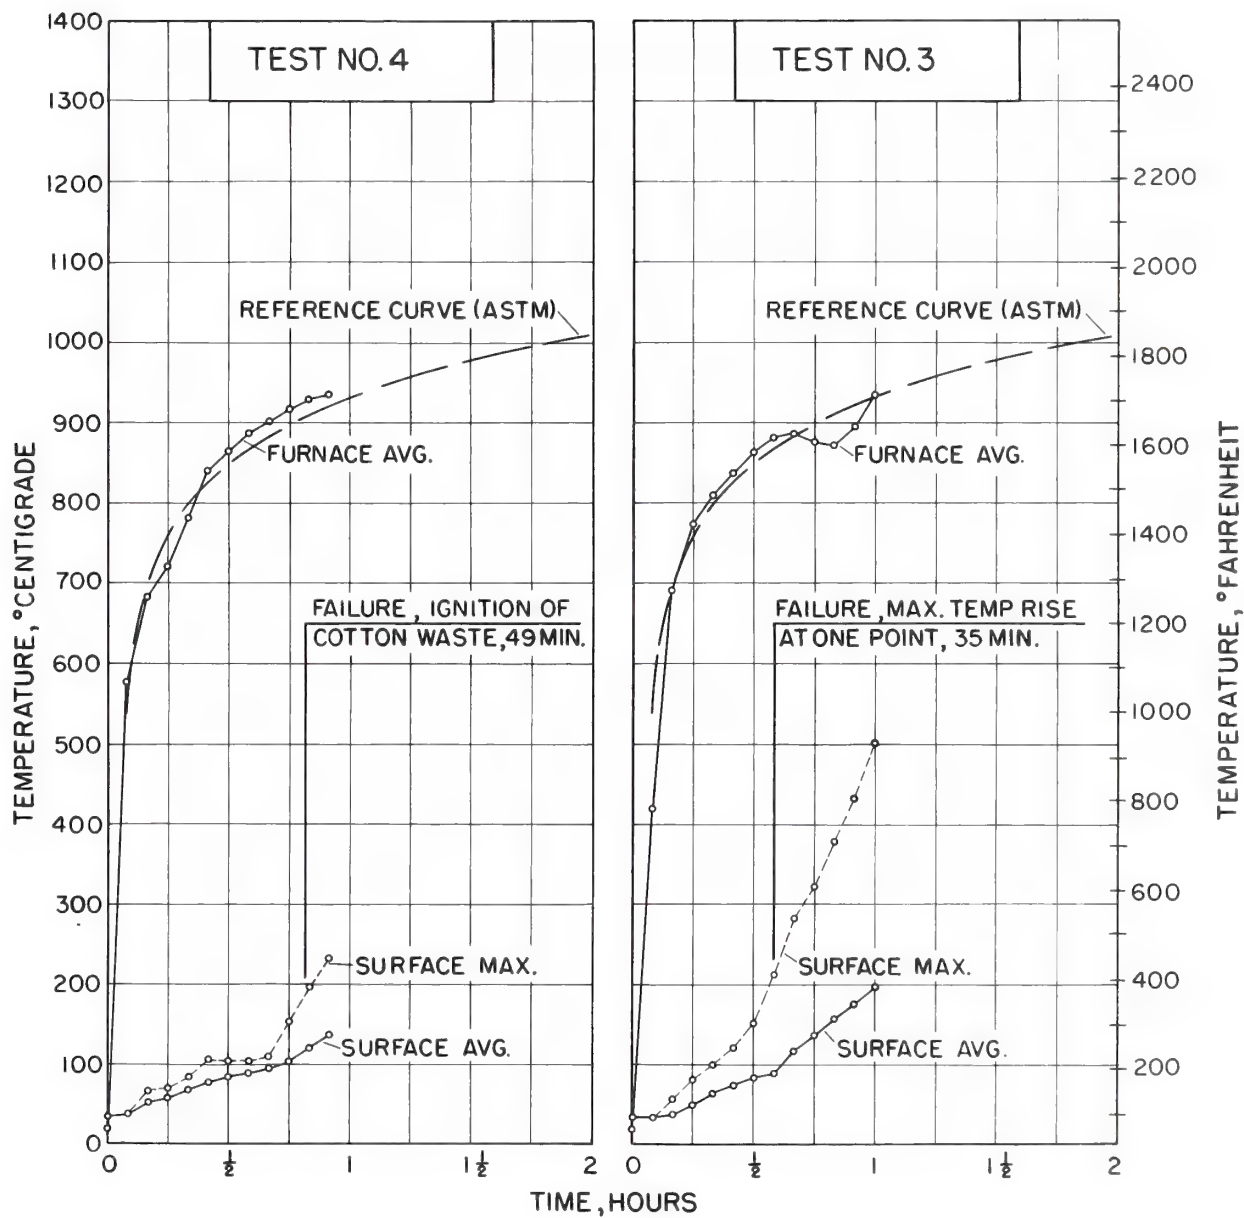
FIG. 7 TIME-TEMPERATURE CURVES FOR TESTS NO. 3 AND 4

The furnace control was such that the fire exposure severity was 98.6 percent of standard. The fire endurance was limited to 35 min. by 325 degree F temperature rise at one thermocouple on the unexposed surface. This thermocouple was located on the cover strip of one of the joints between panels. The wall fire correction was minus 1 min. making the corrected fire endurance 34 min. The temperatures measured during the test are shown in figure 7.

The furnace control was such that the fire exposure severity was 101.5 percent of standard but no correction was applicable to the fire endurance which was listed as 45 min. by the ignition of cotton waste on the exposed surface over the joint between panels. The temperatures measured during the test are shown in Figure 7.

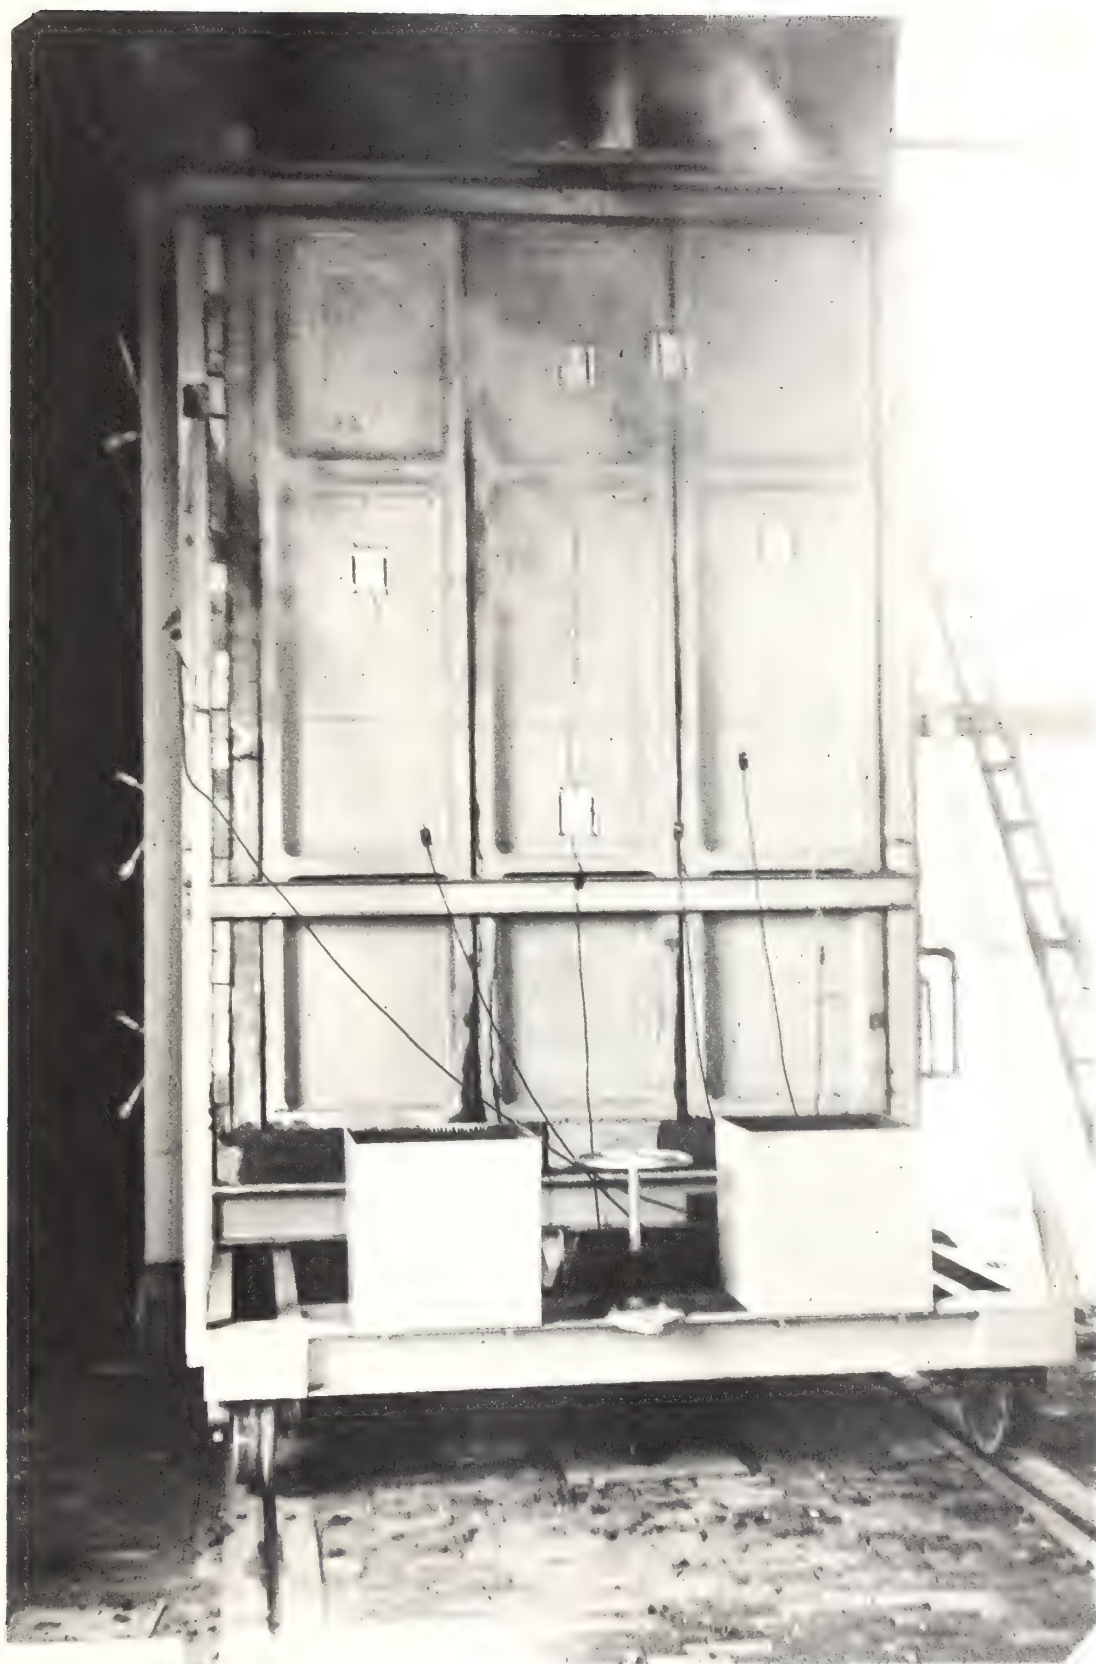
Immediately after the gas was turned off, the test specimen and frame were removed from the furnace. The insulating layer face panel in the center and portions of those on either side had fallen into the furnace chamber. The only damage to the concrete outer face was a spalled spot about 7 in. deep and 6 in. diameter in the center of the upper section of each panel. Deflections of the outer face were negligible.

Fig. 7. Exposed surface of specimen immediately after end of test 1.

Test 1. The inner face would have to be replaced after a standard 2 hr. fire exposure or equivalent and the outer face panels should be patched but could be used as is.
